AN ATTEMPT TO CORRELATE BIMODAL FATIGUE ENDURANCE DISTRIBUTIONS
IN OFHC COPPER WITH WOOD'S H, F AND S RANGES

D. B. Muggeridge

JUNE 1967

UTIAS TECHNICAL NOTE 111

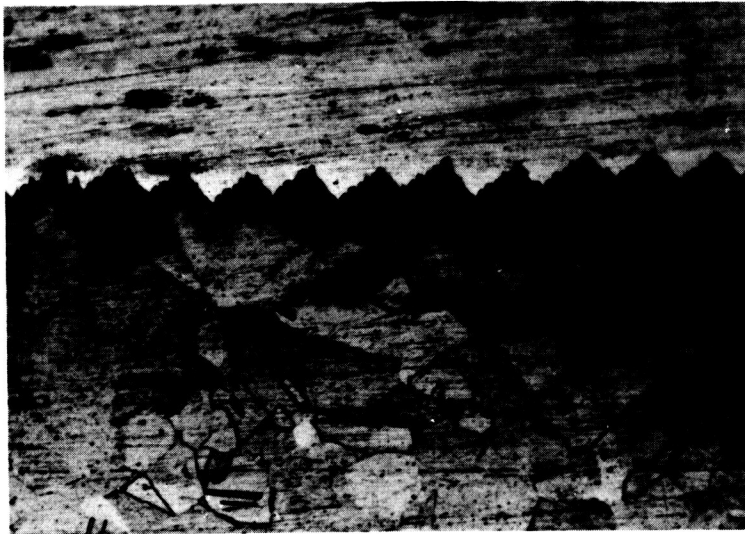
FIG. 9 TYPICAL VIEW OF SURFACE OF SPECIMEN FROM HEAT TREATMENT BATCH A. SURFACE GROOVES ARE LEFT BY FINE-MACHINING AFTER ANNEALING. (x 200).

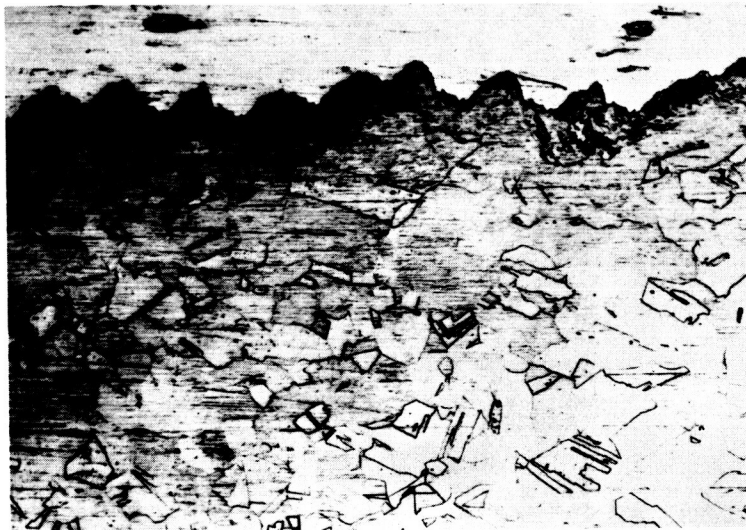
FIG. 10 TYPICAL VIEW OF SURFACE OF SPECIMEN FROM HEAT TREATMENT BATCH C. SURFACE GROOVES ARE LEFT BY FINE-MACHINING AFTER ANNEALING. (x 200).

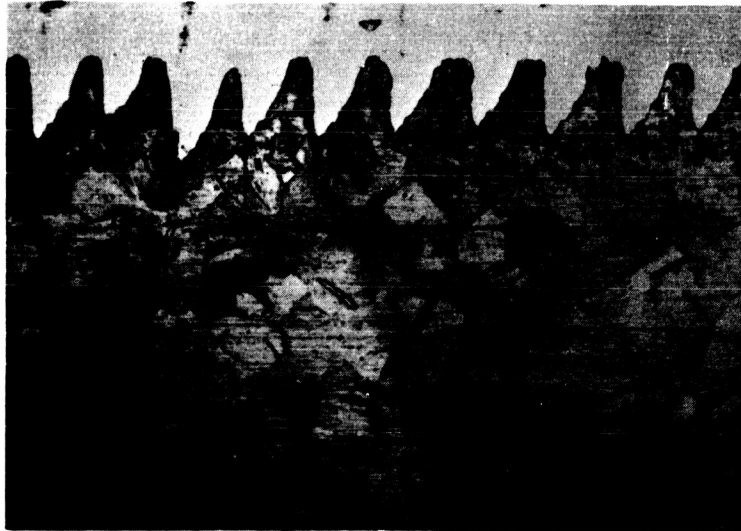
FIG. 11 TYPICAL VIEW OF SURFACE OF SPECIMEN FROM HEAT TREATMENT BATCH B. SURFACE GROOVES ARE LEFT BY FINE-MACHINING AFTER ANNEALING. (x 200).

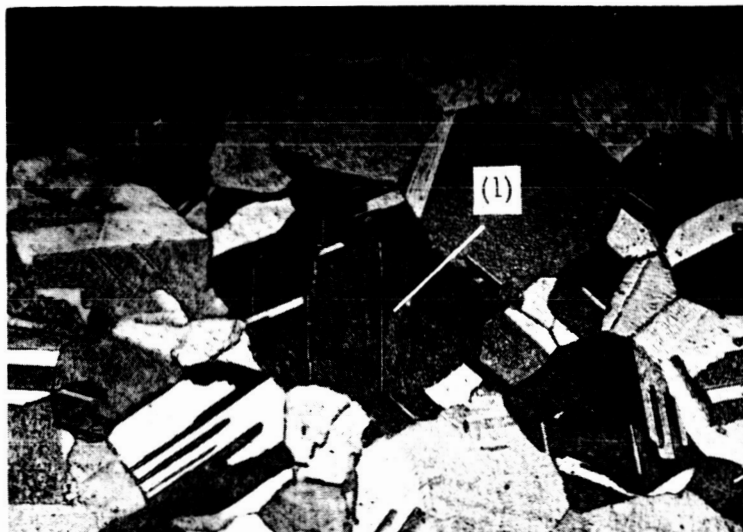
FIG. 26 ETCHED SECTION. DISTORTED SLIP-ZONES, SOME H RANGE MICROSTRUCTURE AND GRAIN BOUNDARY DAMAGE. (B-15, ± 13.0 ksi, x 500).

1. DISTORTED SLIP-ZONES

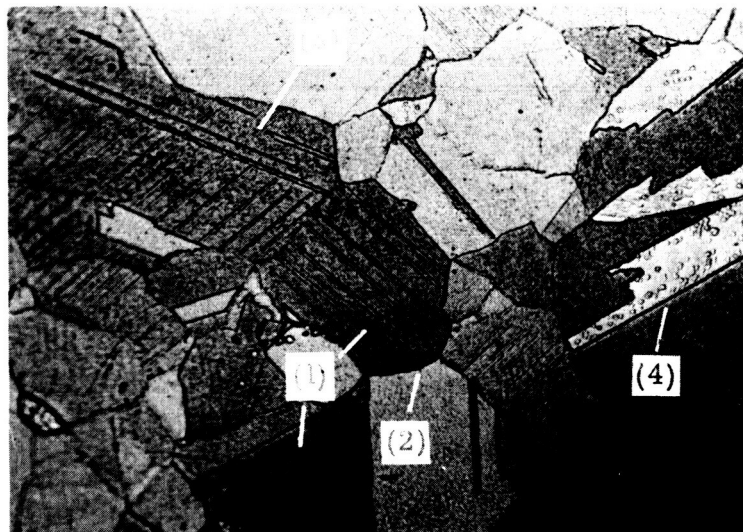
FIG. 28 ETCHED SECTION. DISTORTED SLIP-ZONES AND CROSS SLIP. DEFORMATION OF TWIN BOUNDARIES. SOME H RANGE DAMAGE. (A-59, ± 14.0 ksi, $\times 500$).

1. DISTORTED SLIP-ZONES
2. GRAIN BOUNDARY DAMAGE
3. CROSS SLIP
4. DISTORTION OF TWIN BOUNDARY

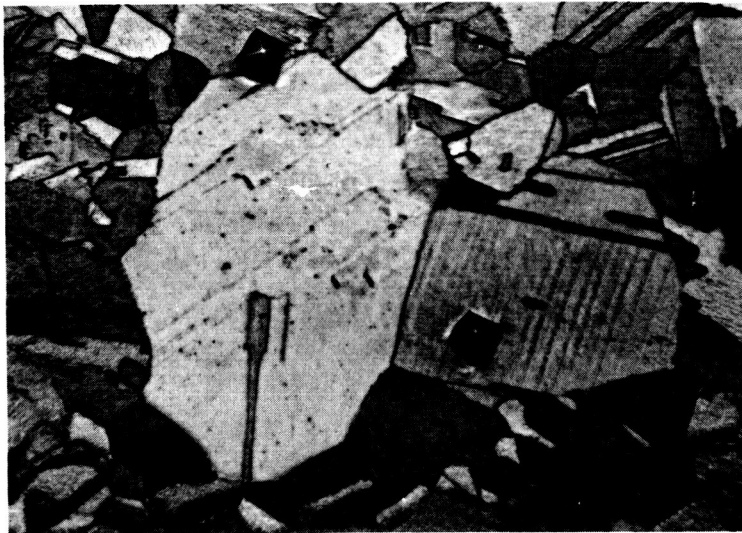
FIG. 35 TYPICAL VIEW OF MICROHARDNESS IMPRESSIONS. LOWER IMPRESSION PLACED IN A GRAIN EXHIBITING FATIGUED SLIP-ZONES. UPPER IMPRESSION PLACED ON BOUNDARY BETWEEN GRAINS SHOWING TWIN BOUNDARY DAMAGE. TOTAL FIELD SHOWS COEXISTENCE OF H AND F RANGE MICROSTRUCTURE. (C-41, ± 16.5 ksi, $\times 500$). REDUCED 20% FOR PRINTING.

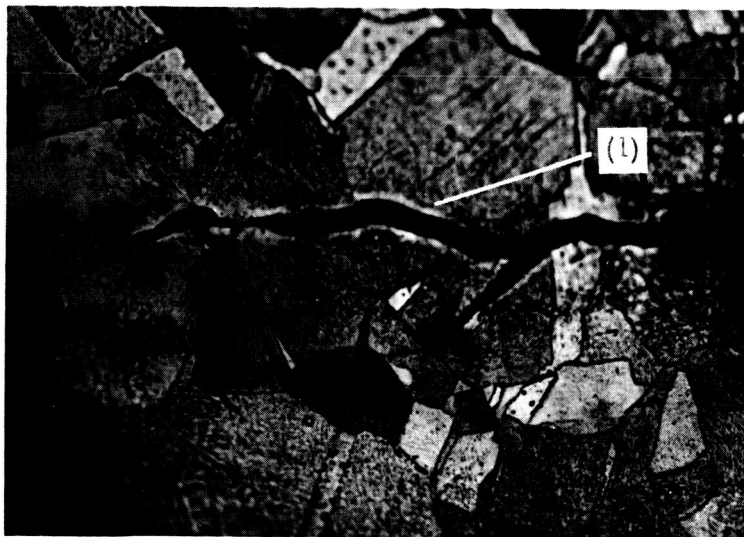
FIG. 42 LONGITUDINAL SECTION THROUGH CRACK. CRACK IN COMPRESSION HALF CYCLE OF STRESS AMPLITUDE. NOTE SECONDARY CRACK AT 45° TO MAIN CRACK. THE STRESS AXIS IS VERTICAL. (A-73 \pm 14 ksi, $8.179 \cdot (10)^5$ cycles, x 500).

1. FRETTING OF SURFACE

Careful electropolishing revealed several crack tip features. The macrocrack was oriented at 90° to the stress axis, which is vertical in Figs. 42-46. (Stage II Crack propagation). The plastic relaxation process as reported by Laird (Ref. 20) is confirmed in Figs. 42-46. Figure 42 shows a crack after $8.179(10)^5$ cycles that has been left in the compression part of the loading cycle. Areas of deformation can be seen in front of and alongside the crack. Juxtaposed depressions can be observed on both fracture surfaces. Figure 43 shows the same macrocrack but unetched. The branch crack that lies at 45° to the main crack direction is thought to be an effect of Plastic deformation, rather than due to quasi-cleavage. It appears not to have been a rest point for the crack. Figure 44 gives an enlarged view of the crack tip of Figs. 42 and 43. This picture clearly shows the asymmetrical notch left at the crack tip in compression. A crack tip in tension after $1.042(10)^6$ cycles is shown in Fig. 45. Figure 46 shows the same crack tip after re-polishing. It should be noted that the width of this crack is appreciably larger than the crack under the compression part of the cycle shown in Fig. 44. Figures 44 and 45 are both at 1000X magnification.

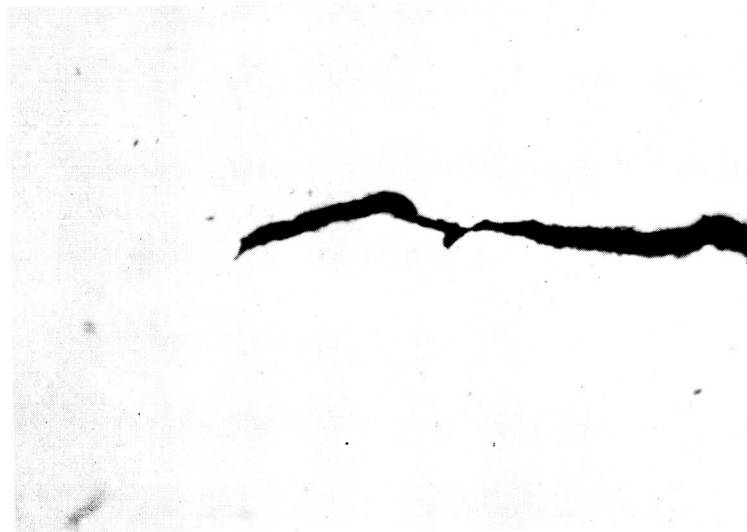
FIG. 44 CRACK TIP PROFILE OF SPECIMEN SHOWN IN FIG. 39 ASYMMETRICAL TIP. (x 1000).
